# Oxford Whole House Carbon Reduction Project

Part of the Retrofit for the Future Programme  
Sponsored by the Technology Strategy Board

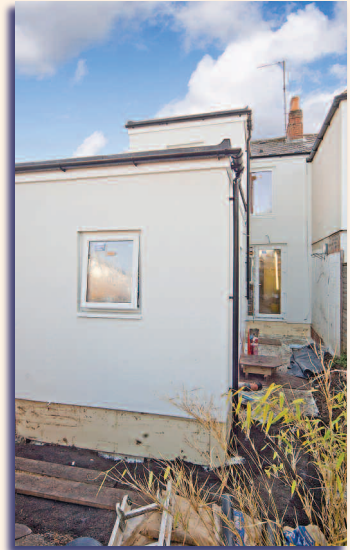
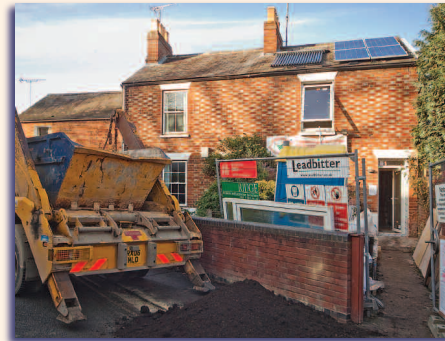
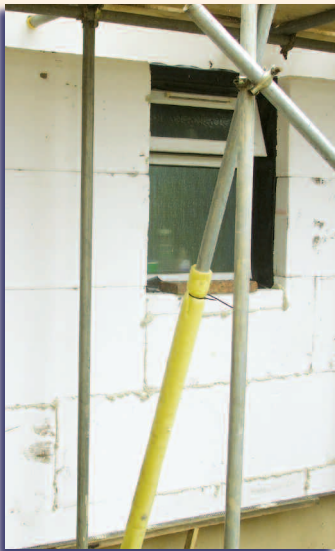
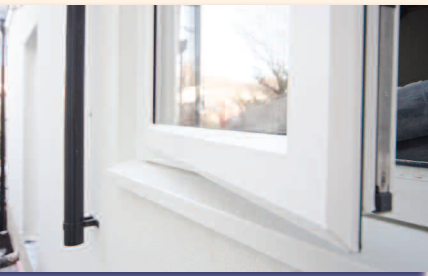
Insulating blocks and triple-glazed  
doors and windows

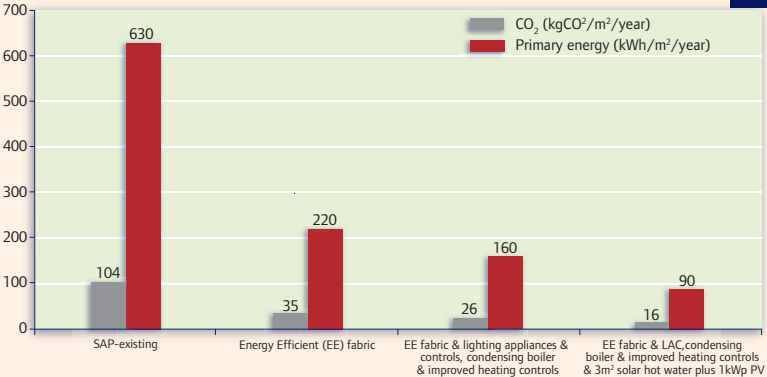
Reductions achieved in CO<sub>2</sub> emissions and primary energy

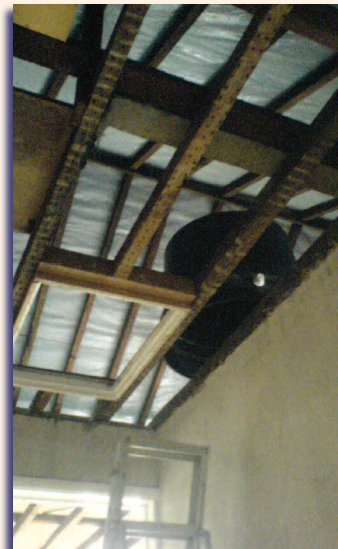
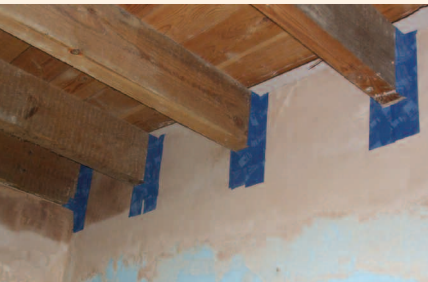
Sealing all gaps to prevent heat loss

Airtightness membranes have been installed in first floor ceilings with all service pipe areas sealed. All gaps and holes in outside walls have been filled. All junctions between floors and walls have been sealed to ensure a low level of heat loss from air leaking out of the building and cold air from entering.

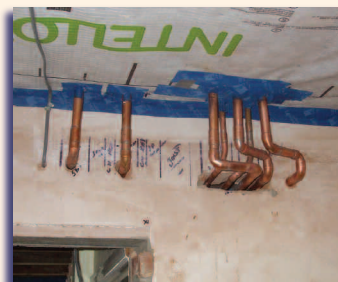
Airtight vapour barrier under slate roof and tape seals around all plumbing

420mm loft insulation at ceiling line with Intelloplus airtight vapour barrier. U-value  $0.1\text{W/m}^2\text{K}$ . Additional ventilation provided in the existing slate roof to avoid the risk of condensation. Insulation added to the cold water tank.

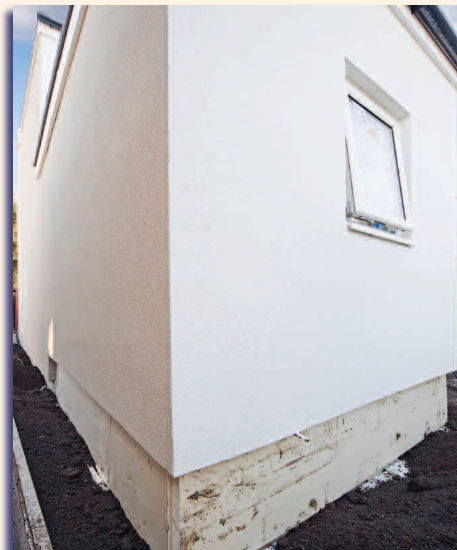
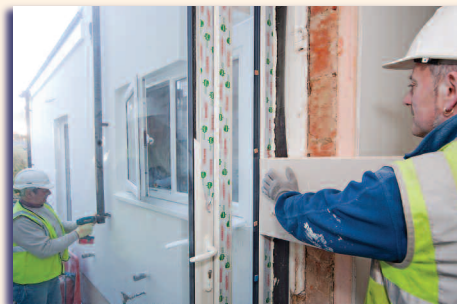
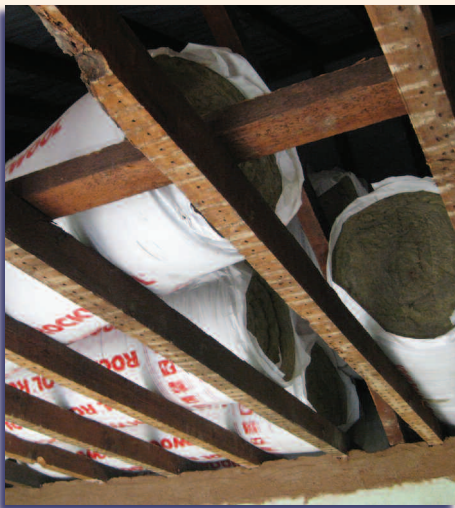
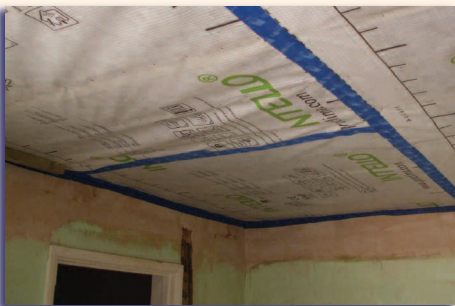
Insulation and airtight membranes sealed with blue ecological system tapes

Timber floor structure retained with masonry fireplace, hearths removed and rotten boards replaced. Wall insulation continuous through floor. Airtightness continuity ensured with ecological building systems tapes.

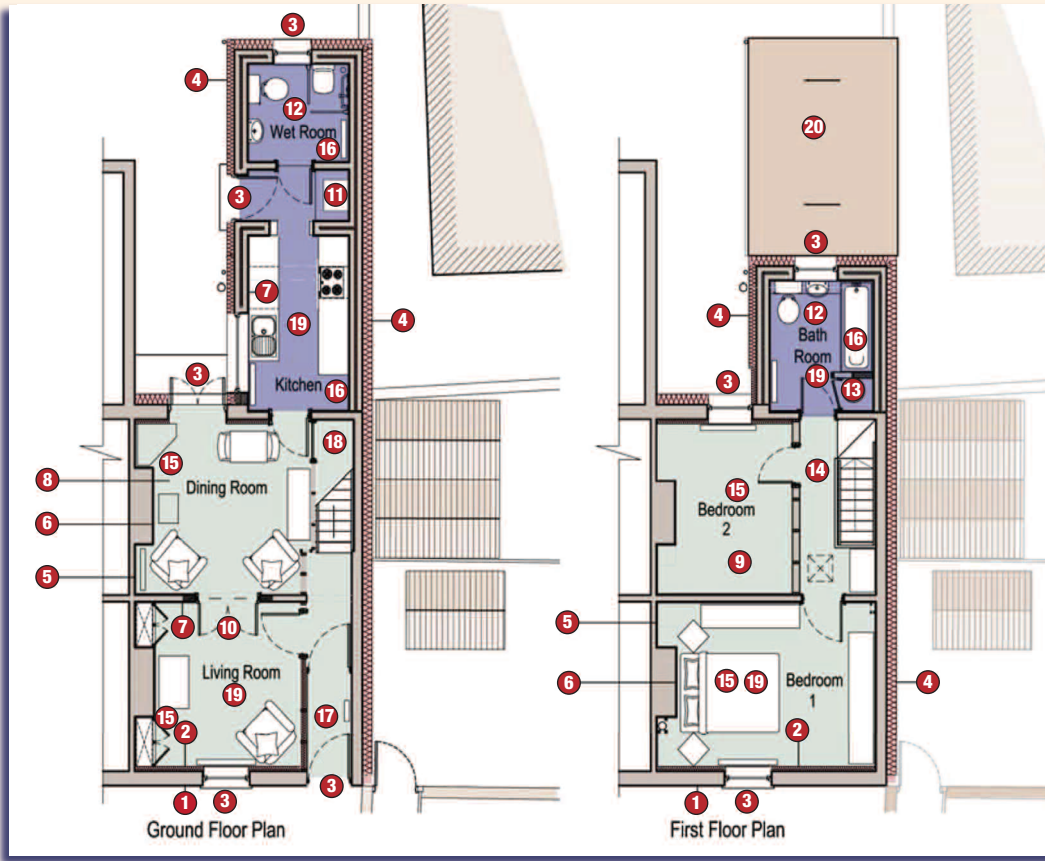
# Retrofitted Nelson Street Property Floor Plans

- 1 Original recycled decorative brickwork retained
- 2 Internal insulation to solid wall to reduce heat loss without affecting external appearance
- 3 New triple-glazed windows and doors reduce heat loss and raise internal surface temperatures

- 4 External insulation reduced heat loss further on northern sides of house
- 5 Party walls insulated
- 6 Chimney stacks insulated
- 7 Internal masonry walls insulated to reduce cold bridge into footings

- 8 Ground floor slab insulated throughout
- 9 420mm of loft insulation above ceiling line with additional ventilation provided for cold roof space
- 10 New opening with fully glazed doors to allow light through house

- 11 New energy-efficient gas fired boiler
- 12 Low flow water-efficient appliance
- 13 New insulated hot water cylinder supplied by solar thermal tubes on roof

- 14 Monovant Suncatcher on landing providing natural light and background ventilation
- 15 Heat recovery unit in loft supplies tempered air to living areas

- 16 Ventilation system extracts air from kitchen and bathroom wet areas to heat recovery unit in loft
- 17 Insulated entrance lobby with fully-glazed doors

- 18 Pulse meters fitted to monitor consumption and micro generation from PVs on the roof
- 19 Rooms monitored for temperature, humidity and CO<sub>2</sub> levels

- 20 New insulated warm flat roof
